10 Wrongs

Don't Make a Right

By AT1 (AW/SW) Sanchez

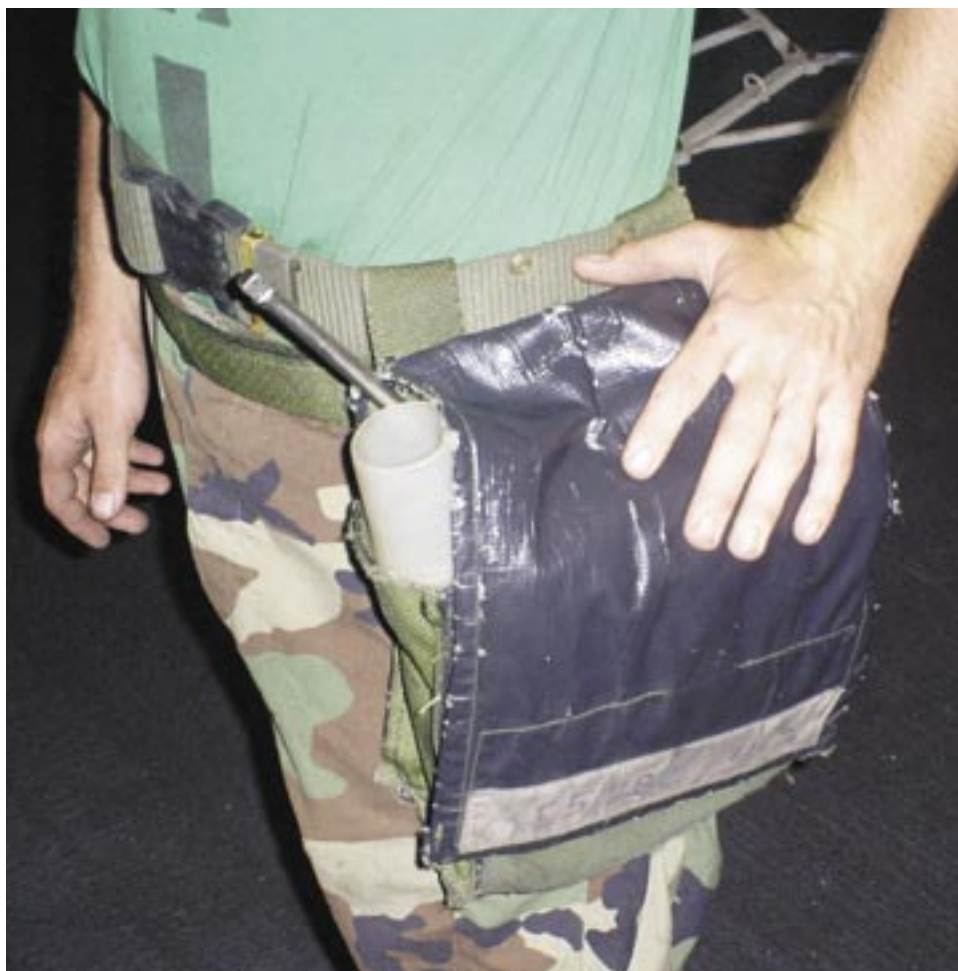
A good tool pouch and inventory procedures keep tools from becoming FOD.
